S799 Servo Bore Repair System:

4L80

This tool is for use on **GM 375, 400, 425,** and **4L80E** transmissions.

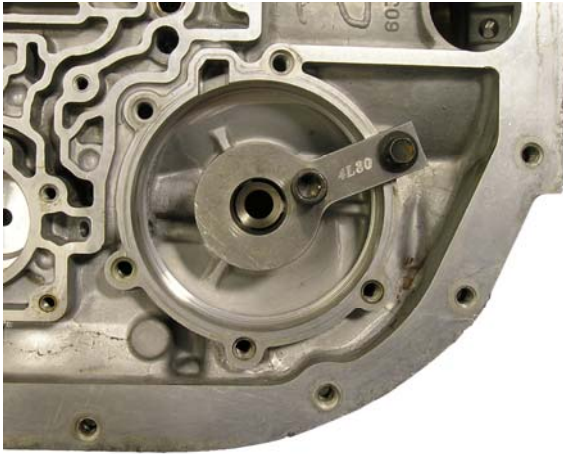
1. Install the drill jig into the case by setting the jig into the servo. Retain the jig in the case with the servo's snap-ring.
2. Drop the 9/16" guide into the jig. It doesn't matter which one of the lands on the guide you use, as long as one of the lands is under the 3/8" Allen screw.
3. Ream out the bore using the 9/16" reamer, applying ample lubrication.* **DO NOT REAM ABOVE 500 RPM.**
4. Replace the 9/16" reamer guide with the 5/8" guide, and the 9/16" reamer with the 5/8" reamer.
5. Ream the bore out using the 5/8" reamer with ample lubrication.* Take care not to either push too hard on the reamer or turn the reamer faster than 500 RPM when reaming. Either one can overly enlarge the bore, causing a loose bushing.
6. Clean the case before proceeding to step number seven.

*- **CUTTING OIL** must be used for lubrication. The use of substitutes, particularly ATF, may result in an over-sized bore.

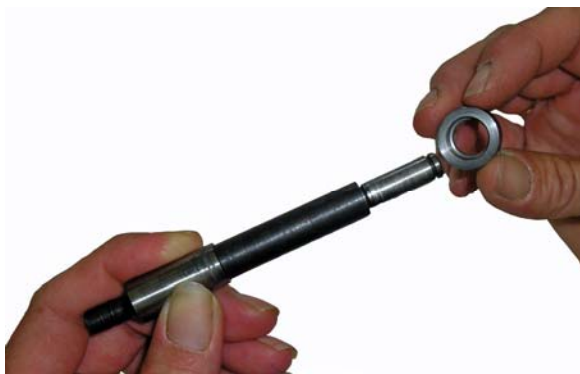
9. Remove the stock Spring Seat (stamped steel) from the Reverse Servo pin and install the new Spring Seat (solid steel). The new spring seat is shorter than the original seat. This is because the area of the case where the seat originally contacted is now covered by the "hat" of the bushing. The new seat has been shortened to provide the correct seat height and made wider to protect the bushing.

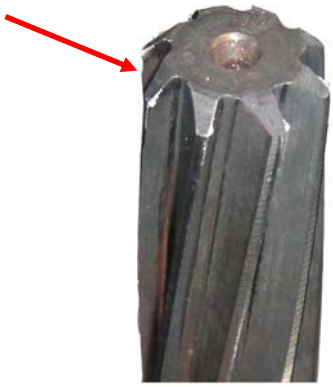
Inspect for aluminum buildups on the cutting edges as pictured left.

Reamers are like drills, if you use them repeatedly in aluminum they develop build-ups on the cutting edges. These build-ups effectively make the reamer larger, causing a larger hole. This larger hole then robs the bushing you're installing of interference needed to properly crush the bushing. This causes the pin to be loose in the bushing, which defeats the entire purpose. To prevent this, you need to (1) keep your reamers sharp and (2) use plenty of CUTTING OIL when reaming.
