**BLACK
SERIES**

S799 Servo Bore Repair System:

5RW

This tool is for use on **FORD 5R55W, 5R55S, and 5R55N** transmissions.

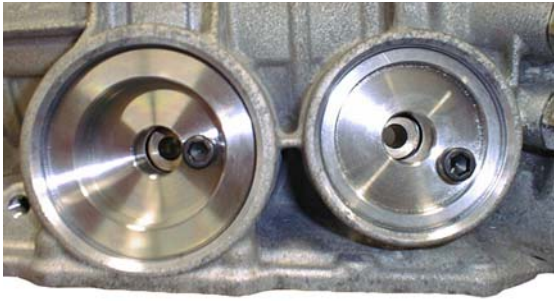
1. Install the drill jig into the case by setting the jig into the servo. Retain the jig in the case with the servo's snap-ring.

2. Drop the 9/16" guide into the jig. It doesn't matter which one of the lands on the guide you use, as long as one of the lands is under the 3/8" Allen screw.

3. Ream out the bore using the 9/16" reamer, applying ample lubrication. * **DO NOT REAM ABOVE 500 RPM.**

4. Replace the 9/16" reamer guide with the 5/8" guide, and the 9/16" reamer with the 5/8" reamer.

5. Ream the bore out using the 5/8" reamer with ample lubrication.* Take care not to either push too hard on the reamer or turn the reamer faster than 500 RPM when reaming. Either one can overly enlarge the bore, causing a loose bushing.

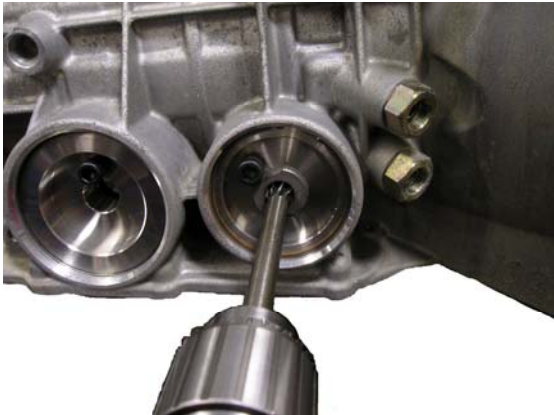
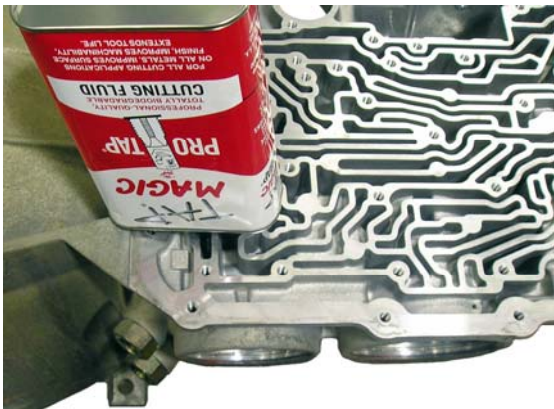
5R55W/S

8. After installing the bushing, using a 15/64" bit, drill a hole in the side of the bushing by following the holes in the case (use the appropriate picture to the left as a map).

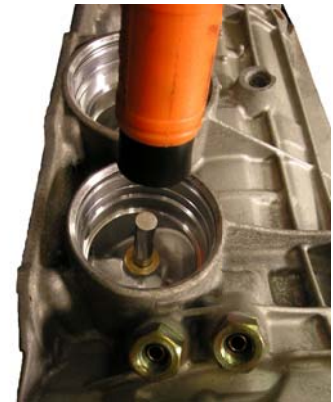
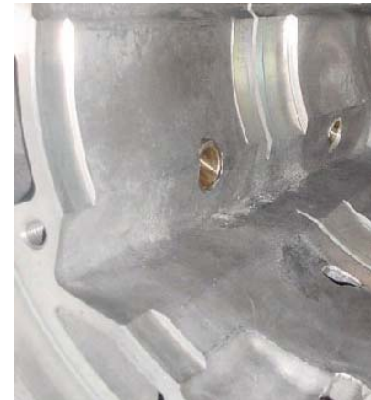
Note: This kit utilizes two different bushings. The shorter bushing is for the Intermediate Servo and is identified by a flat ground in the bushing's hat. Both bushings are chamfered and need to be installed with the recessed edge up (away from the valve body).

Overdrive Bushing

Intermediate Bushing

NOTICE: Notch not necessarily oriented with chamfer

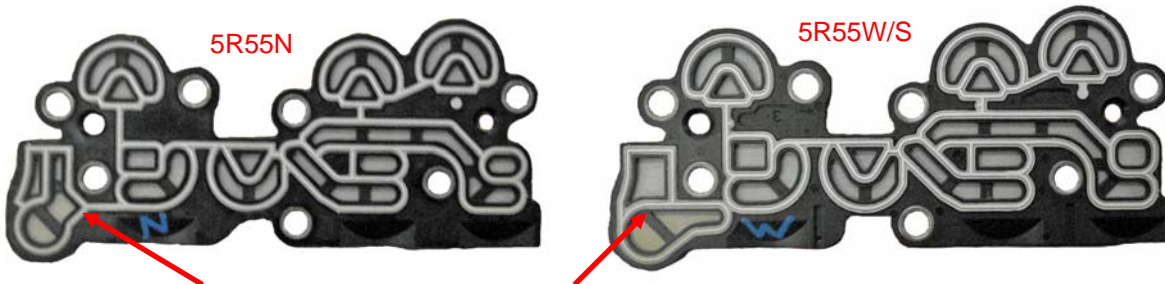
Solenoid Interchange

Always check to insure you have the correct solenoid gasket for your trans.

Look Here.

Wrong gasket will cause a clunk and no reverse condition

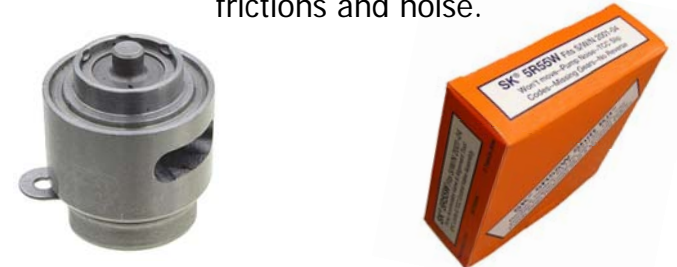
The stock Flow Control Assembly will either stick, causing loss of movement or wear out, causing burnt frictions and noise.

We recommend Transgo's® Shift Kit® which includes an improved assembly
