**GOLD
SERIES**

S799 Servo Bore Repair System:

4L60

This tool is for use on **General Motors 700R4** and **4L60E** transmissions.

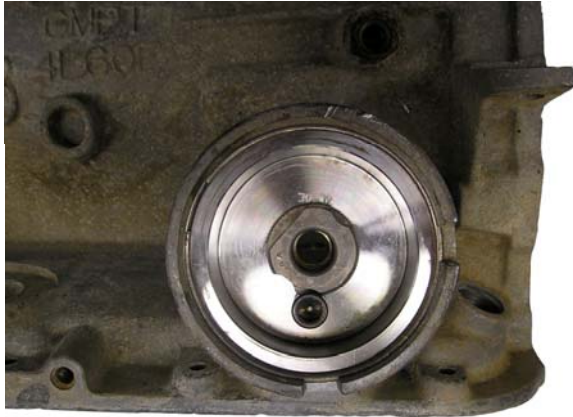
1. Install the drill jig into the case by setting the jig into the servo. Retain the jig in the case with the servo's snap-ring.
2. Drop the 5/8" guide into the jig. It doesn't matter which one of the lands on the guide you use, as long as one of the lands is under the 3/8" Allen screw.
3. Ream out the bore with the **PILOTED** 5/8" reamer, applying ample lubrication.* **DO NOT REAM ABOVE 500 RPM.**
4. Replace the 5/8" reamer guide with the 11/16" guide, and the **PILOTED** 5/8" reamer with the **PILOTED** 11/16" reamer.
5. Ream the bore out using the **PILOTED** 11/16" reamer with ample lubrication.* Take care not to either push too hard on the reamer or turn the reamer faster than 500 RPM when reaming. Either one can overly enlarge the bore, causing a loose bushing.
6. Clean the case before proceeding to step number six.

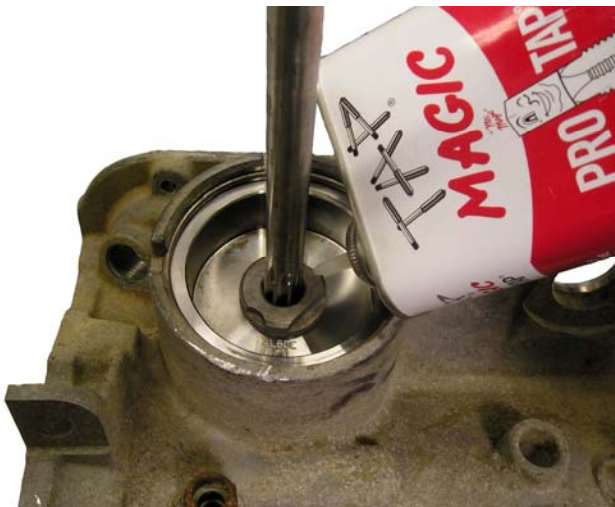
****ALWAYS CHECK PIN FINISH FOR ****
****BURS AND COARSNESS****

7. Apply Loctite® (preferably **green #680**) or equivalent to the bushing and drive the bushing in by hitting the driver until the bushing bottoms. The 4L60 kit uses the larger diameter installation tool with a shorter handle.
8. After installing the bushing, using a 1/4" bit, drill a hole in the side of the bushing by following the passage in the case.
9. Insert the provided sizing pin into the bore, chamfer first. It may be necessary to start the pin in the bushing with a rubber mallet. Once the pin is inside the bushing, use a punch to drive the pin all the way through the bushing. Repeat as necessary.

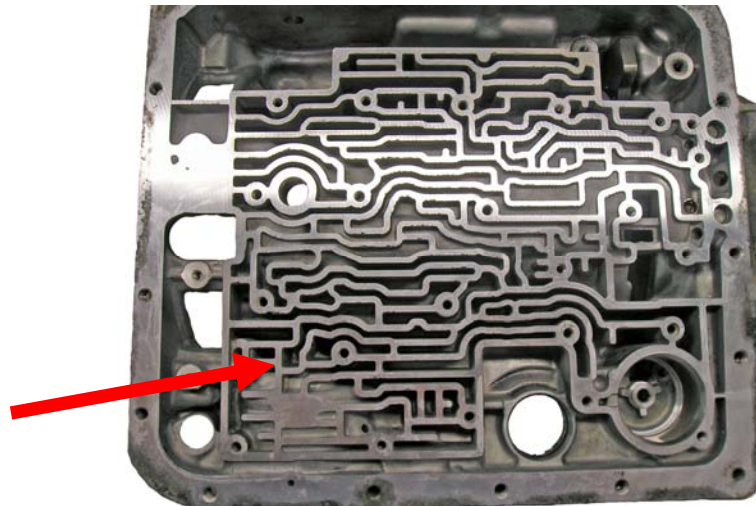
**Don't Forget to Drill
the Apply Hole Here.**

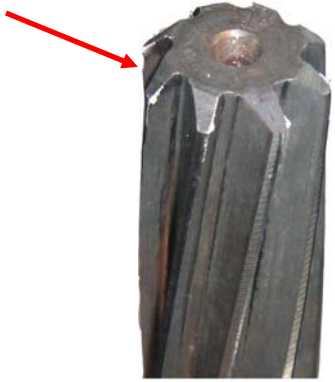
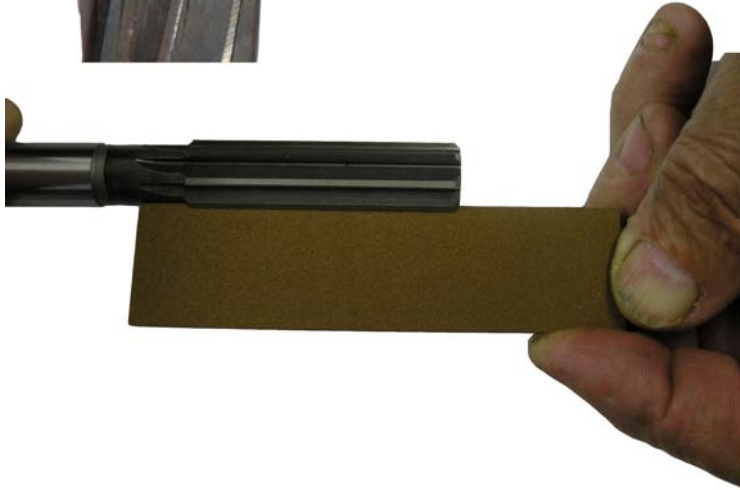
Important Reamer Info

Inspect for aluminum buildups on the cutting edges as pictured left.

Reamers are like drills, if you use them repeatedly in aluminum they develop build-ups on the cutting edges. These build-ups effectively make the reamer larger, causing a larger hole. This larger hole then robs the bushing you're installing of interference needed to properly crush the bushing. This causes the pin to be loose in the bushing, which defeats the entire purpose. To prevent this, you need to (1) keep your reamers sharp and (2) use plenty of CUTTING OIL when reaming.
