**GREEN  
SERIES**

*S799 Servo Bore Repair System:*

**4T60-F**

This tool is for use on **General Motors 4T60E** and **4T65E** transaxles.

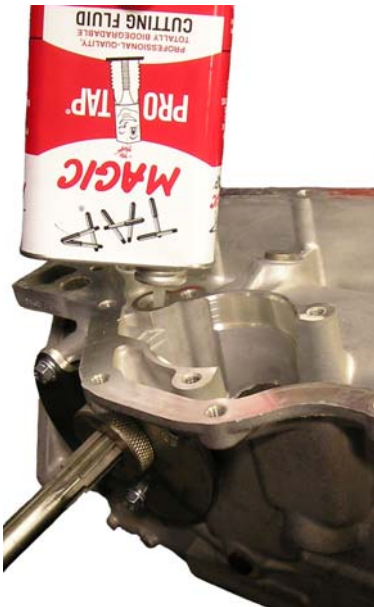
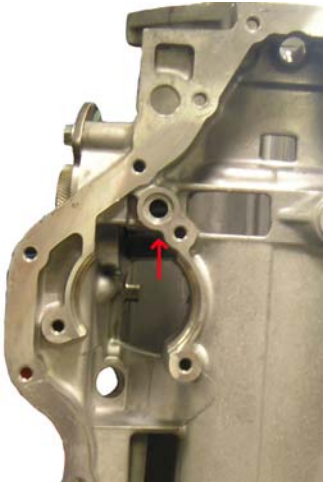
7. Apply Loctite® (preferably **green #680**) or equivalent to the bushings and drive the bushings in by hitting the driver until the bushing bottoms.

8. After installing the bushing, using a 13/32" bit, drill a hole in the side of the bushing by following the hole in the case (use the picture to the left as a map). Take care not to make the passage oblong.

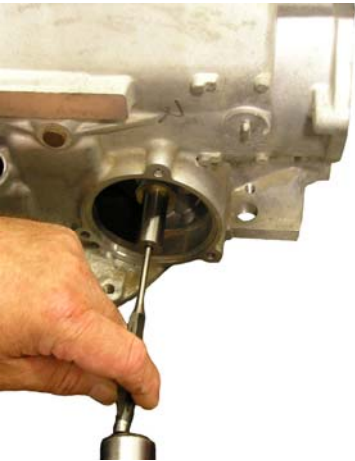
9. Insert the provided sizing pin into the bore, chamfer first. It may be necessary to start the pin in the bushing with a rubber mallet. Once the pin is inside the bushing, use a punch to drive the pin all the way through the bushing. Repeat as necessary.

**\*\*ALWAYS CHECK PIN FINISH FOR \*\*  
\*\*BURS AND COARSNESS\*\***

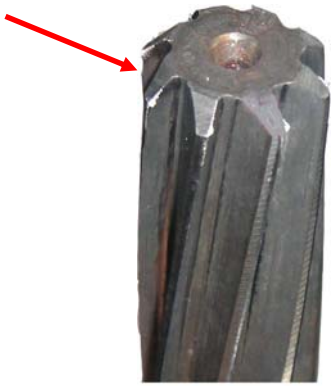
Inspect for aluminum buildups on the cutting edges as pictured left.

Reamers are like drills, if you use them repeatedly in aluminum they develop build-ups on the cutting edges. These build-ups effectively make the reamer larger, causing a larger hole. This larger hole then robs the bushing you're installing of interference needed to properly crush the bushing. This causes the pin to be loose in the bushing, which defeats the entire purpose. To prevent this, you need to (1) keep your reamers sharp and (2) use plenty of CUTTING OIL when reaming.
